DEPARTMENT OF TRANSPORTATION

Contract #: 04-0120F4Cty: SF/ALA Rte: 80 PM: 13.2/13.9File #: 69.28**WELDING INSPECTION REPORT****Resident Engineer:**Siegenthaler, Peter**Address:** 333 Burma Road**City:** Oakland, CA 94607**Report No:** WIR-022477**Date Inspected:** 07-Apr-2011**Project Name:** SAS Superstructure**OSM Arrival Time:** 700**Prime Contractor:** American Bridge/Fluor Enterprises, a JV**OSM Departure Time:** 1900**Contractor:** Zhenhua Port Machinery Company, Ltd (ZPMC), Changxing Island **Location:** Shanghai, China**CWI Name:** Zhu Zhong Hai**CWI Present:** Yes No**Inspected CWI report:** Yes No N/A**Rod Oven in Use:** Yes No N/A**Electrode to specification:** Yes No N/A**Weld Procedures Followed:** Yes No N/A**Qualified Welders:** Yes No N/A**Verified Joint Fit-up:** Yes No N/A**Approved Drawings:** Yes No N/A**Approved WPS:** Yes No N/A**Delayed / Cancelled:** Yes No N/A**Bridge No:** 34-0006**Component:** Orthotropic Box Girder(OBG)**Summary of Items Observed:**

OBG # TRIAL ASSEMBLY YARD**WELDING:****Segment 13AW**

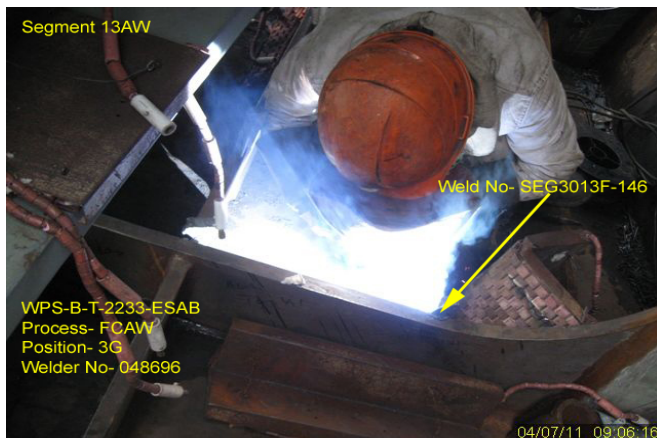
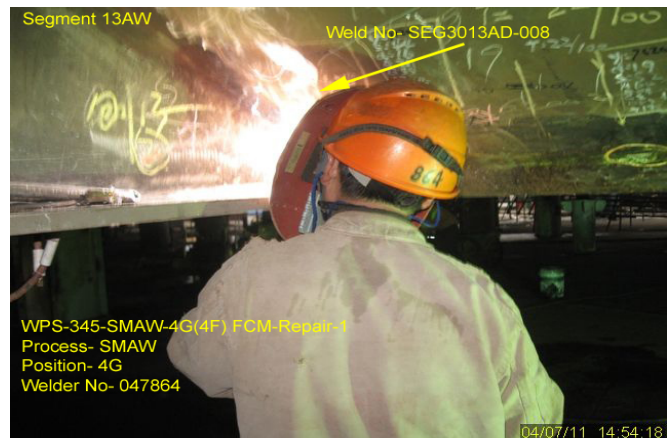
This QA Inspector observed ZPMC qualified welding personnel identified as 048696 perform Flux Core Arc Welding (FCAW), weld joint identified as SEG3013F-148; located On Orthotropic Box Girder (OBG) Side Plate to Stiffener CJP Weld; ZPMC Quality Control (QC) is identified as Mr. Zhang Qiang. This QA Inspector observed a welding current of approximately 270.8 amps and 27.1 volts and the base material appears to have been being preheated by an electrical heating elements prior to welding .ZPMC Quality Control (QC) Mr. Zhang Qiang was onsite monitoring the welding variables. The welding variables recorded by QC appeared to comply with applicable WPS-B-T-2233-ESAB. See attached photo for further details.
